THE LION CHAMBERS

PROPOSED CREATIVE CO-WORKING & LEARNING SPACE IN GLASGOW

BUILDING CONDITION & MAPPING

MSc ARCHITECTURAL DESIGN FOR THE CONSERVATION OF BUILT HERITAGE UNIVERSITY OF STRATHCLYDE - GLASGOW
CONSERVATION DESIGN PROJECT - ELINA MARIA YLIMAKI - 2020 / 2021

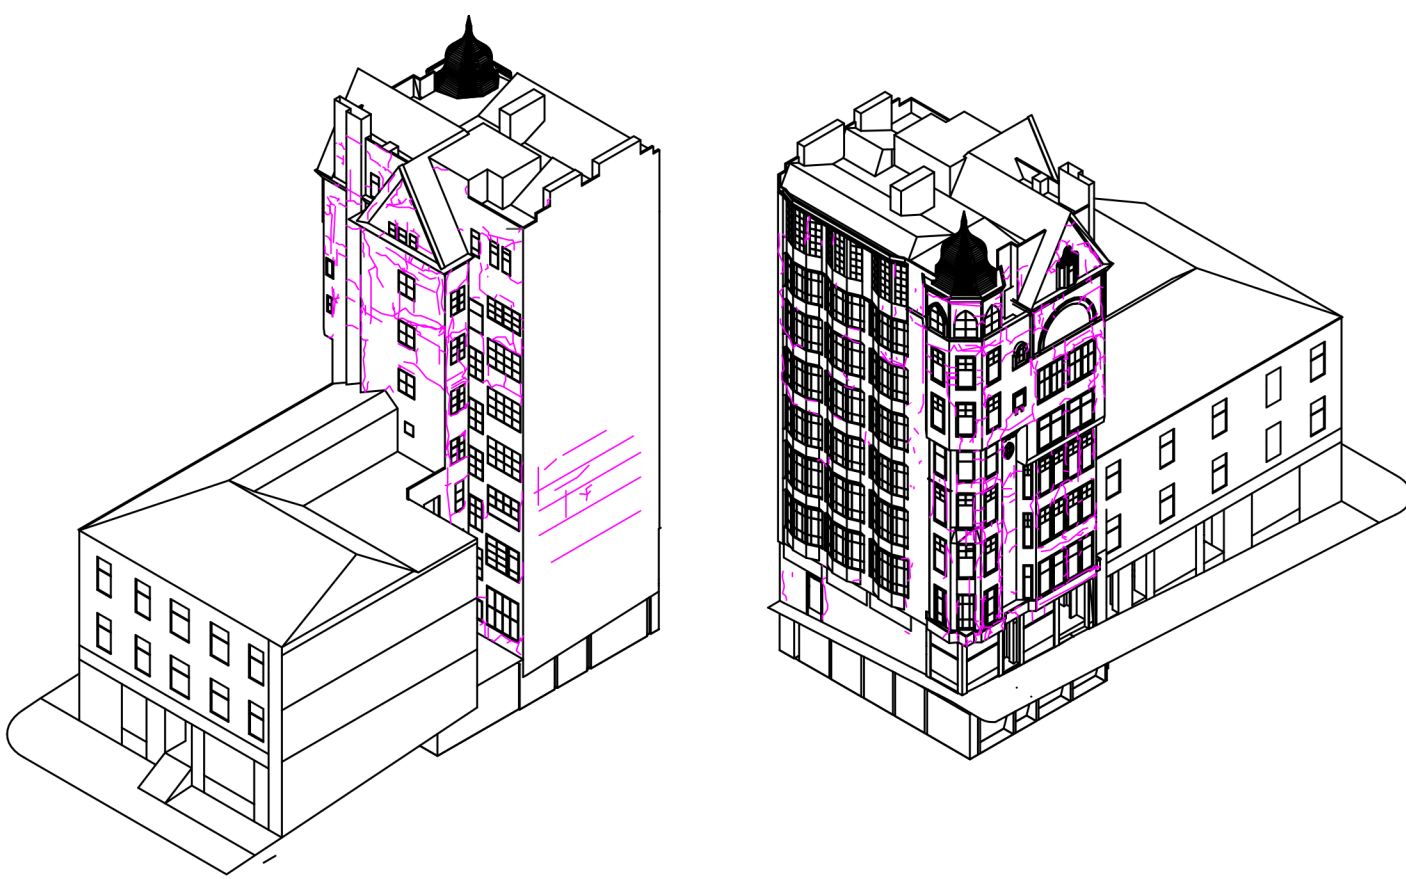
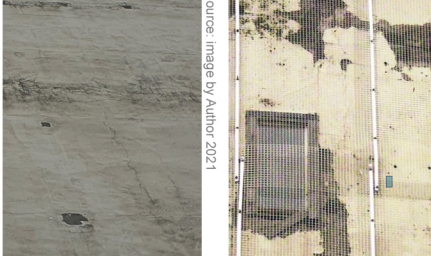
CRACKS

Pathology	Cause of decay	Further investigation	Proposed intervention
Cracks	Non structural cracks are common in reinforced concrete which often occur during and just after the construction phase and thereafter. Cycles of wet and dry can cause surface cracking. For example due to faulty rainwater goods. Historic concrete was often affected by poor workmanship and issues relating to how the concrete was mixed, placed and cured.	Any structural cracks to be addressed by a structural engineer. Prepare site test to evaluate if the cracks are structural or non structural and what the main cause is. Cracks are generally the buildings way of creating a movement joint as a structural connection should be installed or a movement joint should be formed to structural engineers details.	A fine cement grout is the best material for crack repair if the investigation has been done before commencement of the works or there is a risk that the cracks will reappear.

Surface cracking (and spalling) visible on the concrete surface.

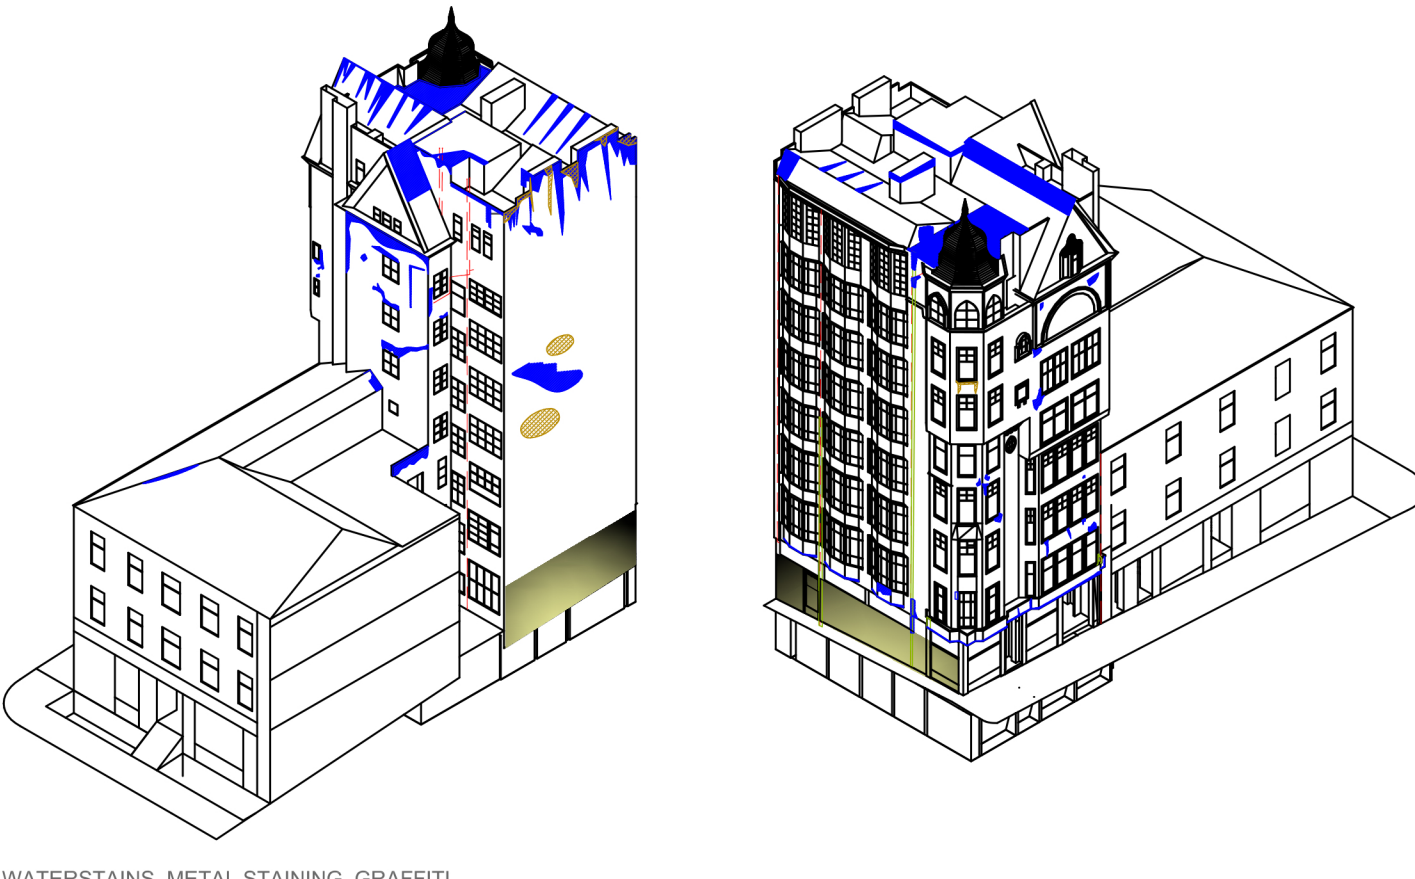
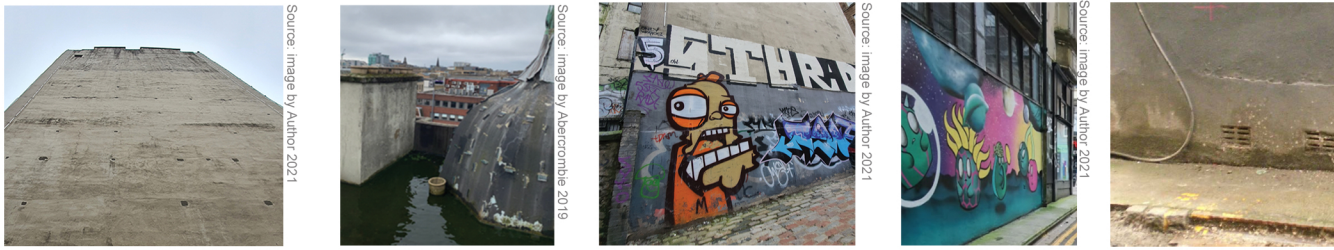
WATERSTAINS, METAL STAINING, GRAFFITI

Pathology	Cause of decay	Further investigation	Proposed intervention
Water stain	Water stains on walls and pooling of water on the roof are possibly due to decayed watergoods, blockage and poor detailing.	A full detailed visual inspection of the rainwater goods. CCTV cameras through drain pipes may be necessary to investigate any blockages/ damage which may cause water stains. Measure the absolute moisture content with the help of samples and measure the weight differences of various concrete samples, saturated with water and dry samples to make a comparison. An alternative method of measuring moisture is the capacitance moisture meter, which is a quick method to estimate moisture levels. Although not providing an absolute measure it gives an indication of the levels. Readings can be affected by contaminations or salt for example. Use of wooden pine dowels is another method where wooden rods are isolated from the concrete with a rubber band in the sealed holes. They are left in the concrete for a minimum of three weeks. This will give the wood a chance to reach equilibrium.	Overhaul decayed watergoods and dry out the concrete. Renewal of the rainwater goods perhaps also upgrading sizes due to additional rainfall and climate change. Possibly adding a 'jacket cover' over the building for some length of time to give the building a chance to dry out.

Graffiti	Existing graffiti paintings on walls which may be of historic interest, that could be preserved.	Investigate if the paint is harming the concrete or if some of the graffiti can be preserved or painted over or incorporated with new murals from a removed artist.	Clean or paint over some of the graffiti which may be covered or not of historic interest. Invite an artist to paint a piece of art work on the back wall to celebrate the history of the Lion Chambers.
Discolouration/ metal staining	Corrosion of rebars.	Cleaning to BS 8221-1:2000 Code of practice. (Guidance only). Sample tests to be done before commitment.	Stained area to be corded out and then sample test should be used to remove the stains with dilute acid (sulfuric or nitric acid) (2012, Odgers)

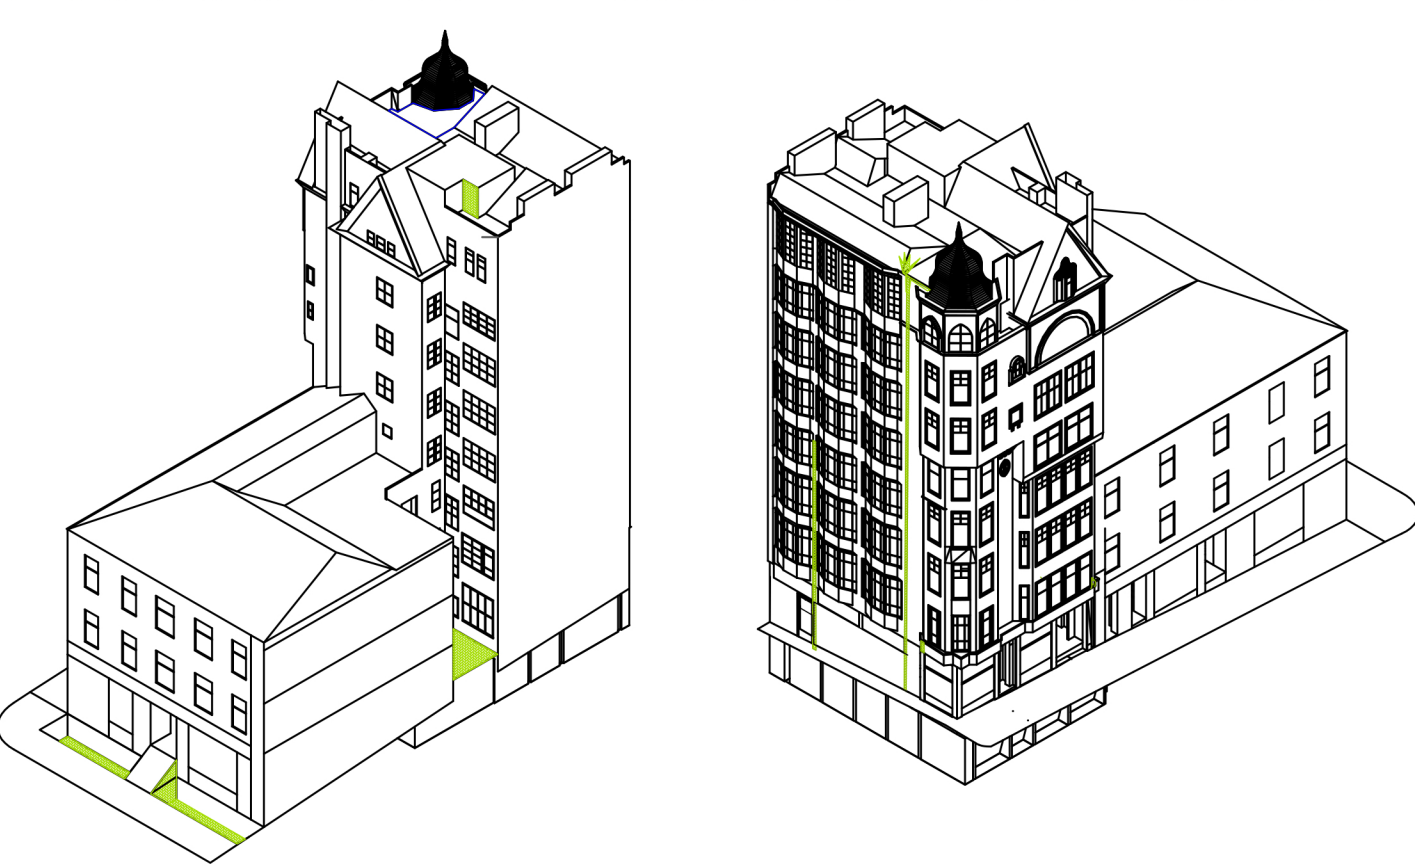
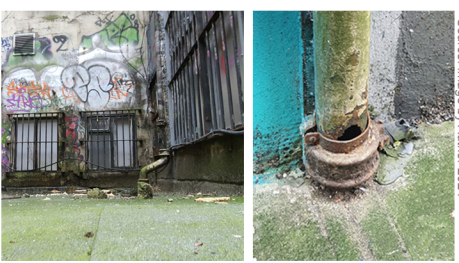
BIOLOGICAL DETERIORATION

Pathology	Cause of decay	Further investigation	Proposed intervention
Plants	Plants and biological deterioration like algae thrive in wet and damp environments. When the concrete slowly carbonates over time it becomes porous and where there is damp the algae and moss can easily grow.	Laboratory tests are helpful to investigate the type of biological plants on the surfaces.	Removal of any visible plants including the roots. Cleaning of the possible algae to BS 8221-1:2000 Code of practice. (Guidance only). The cause of the biological components has to be addressed first or it will reappear soon after.

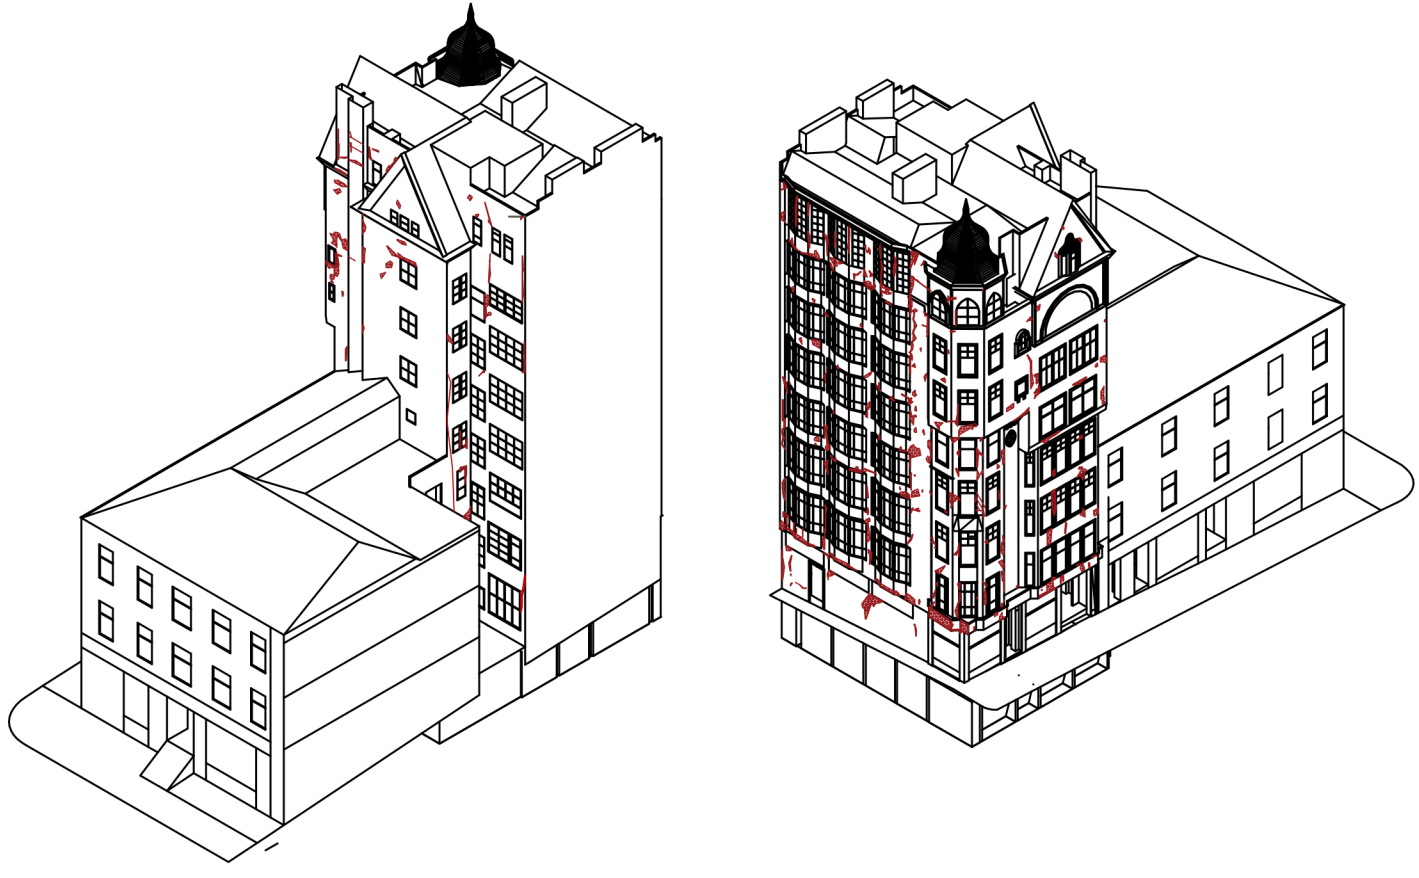
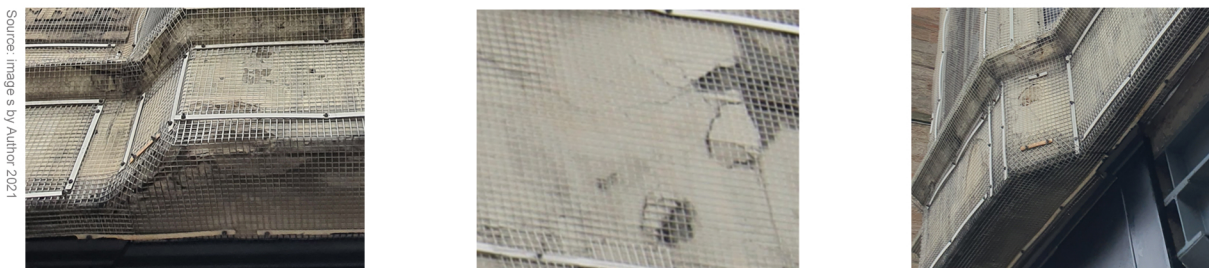
SPALLING

Pathology	Cause of decay	Further investigation	Proposed intervention
Spalling	Spalling is characterized by fragments, scales or slabs falling of the concrete. Spalling is the end result of delamination or cracking and can be caused by the following: frost, sulphate attack, salts and corrosion of rebars.	Investigate the area to be patched required, if it has high levels of chlorides. with various samples 75 mm from the surface, to be tested in a laboratory.	Patch repairs to blend in with existing concrete. There are risks if there are high levels of chlorides in the concrete in combination with the use of high alkali mortar which is supposed to suppress corrosion. This can remove the corroding anode which has protected the surrounding less contaminated cathodic areas. It is rare in non contaminated concrete. British Standard: Repair of the existing fabric to BS EN 1504:2008 products and systems for the protection and repair of concrete.

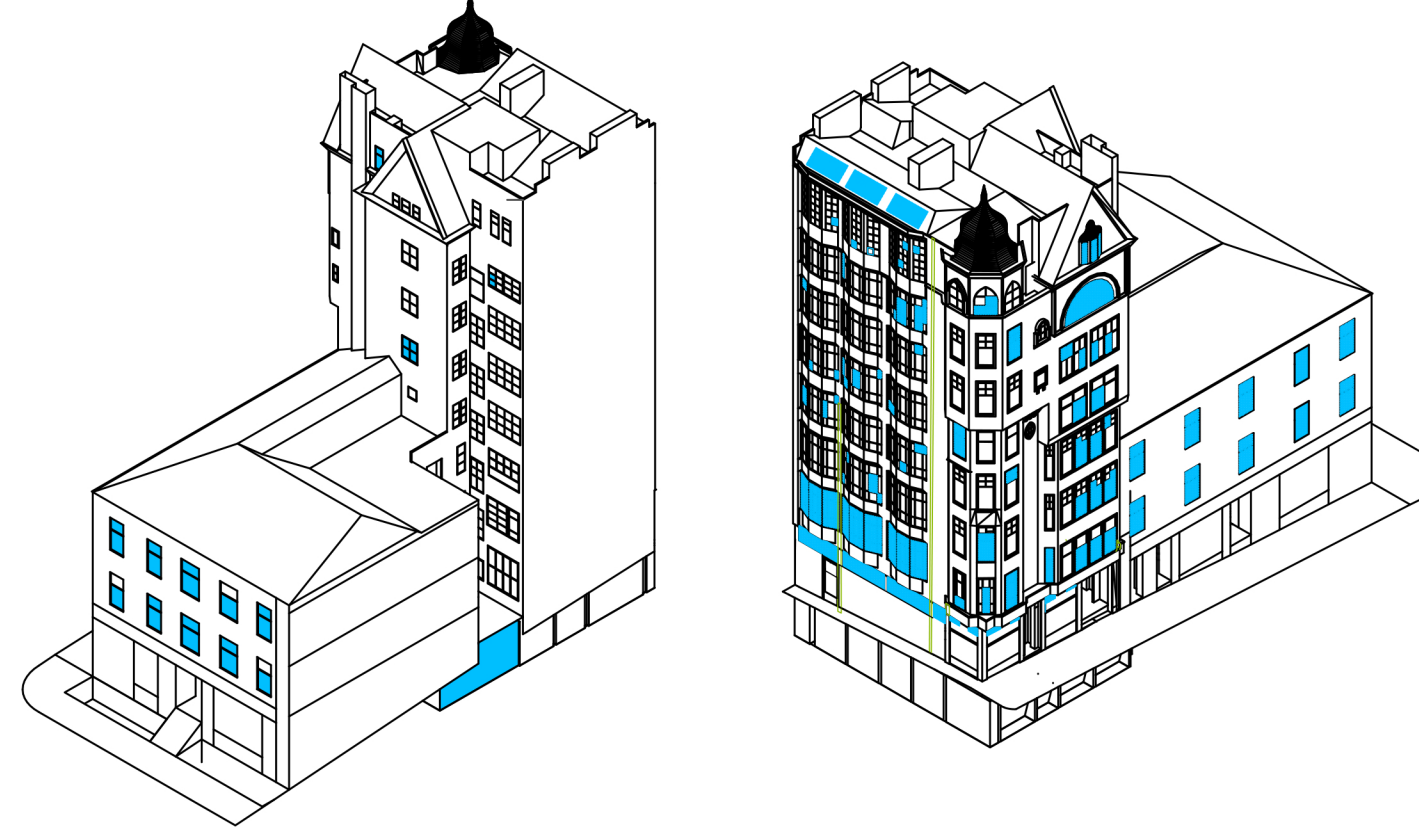
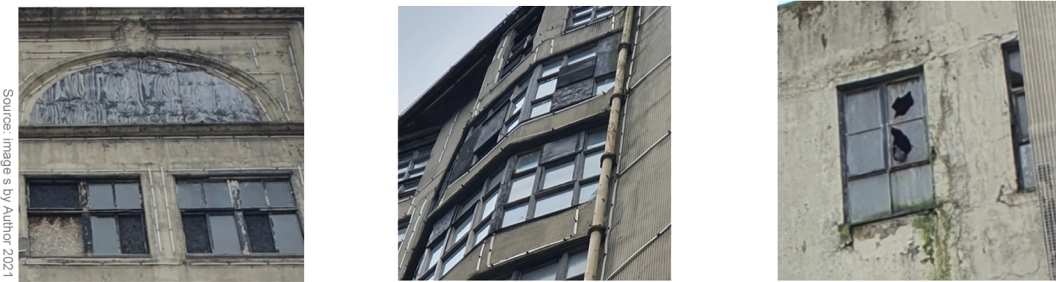
MISSING/ BROKEN OR COVERED WINDOWS

Pathology	Cause of decay	Recommended further investigation	Proposed intervention
Missing/broken or covered windows	The timber sash windows has not been regularly maintained. The metal windows (both metal and timber) have not been maintained regularly and after from decay and broken glass.	Additional surveys of the window sizes and careful detailing is needed. Sample windows to be produced.	Update all windows to slimline heritage triple glazing to match existing windows. To help with reducing the carbon footprint. Possibly aluminium composite windows with timber frame.

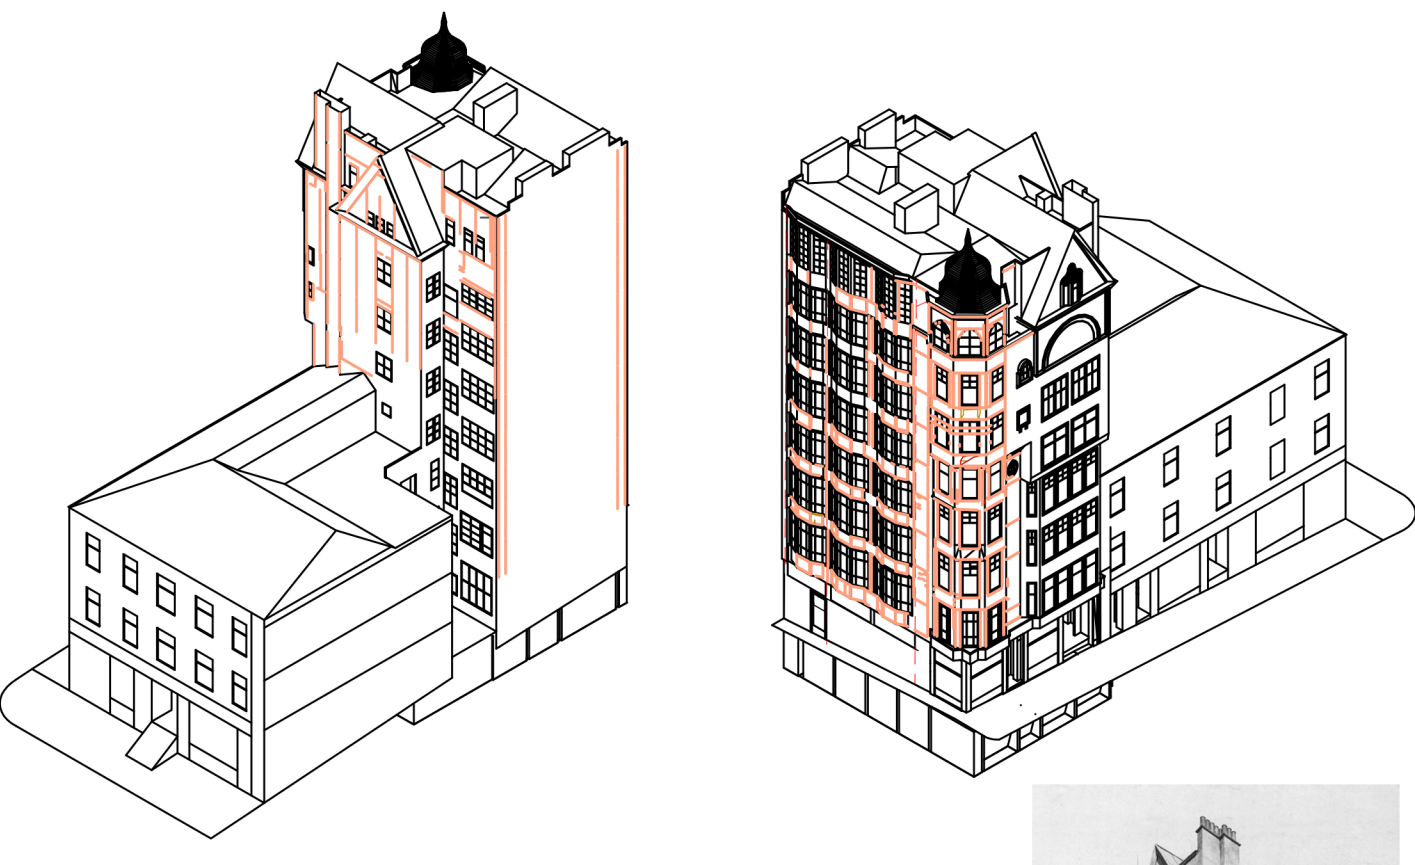
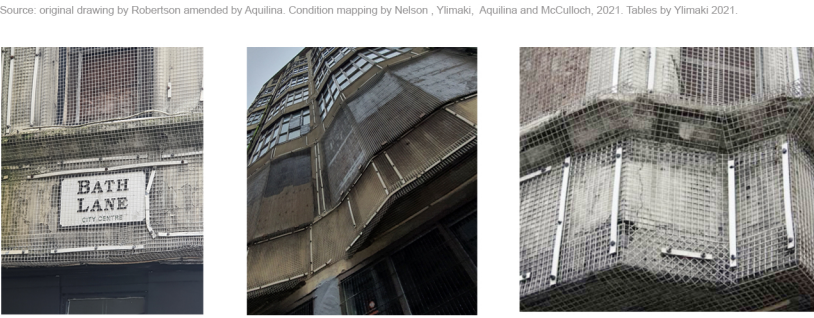
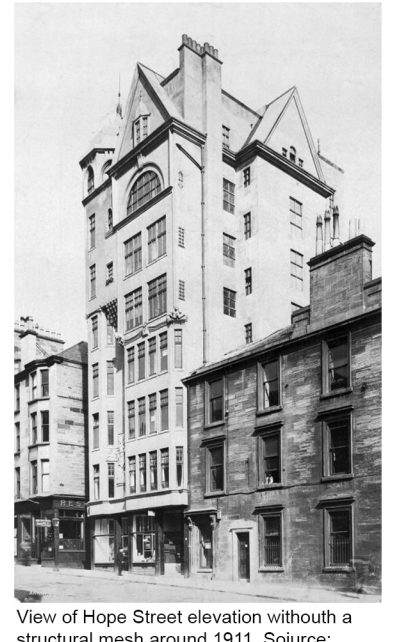
STEEL BARS AND MESH

Pathology	Cause of decay	Further investigation	Proposed intervention
Steel bars (including as ferris and mesh)	The structural steel mesh was installed in 2004 to stop spalling concrete from falling. (Parker, 2012). It is fixed with H16 screws and removal of H16 screws will cause damage to the existing concrete fabric, which has to be repaired.	Structural steel mesh removal and process to be investigated by a structural engineer. Repair of the existing fabric to BS EN 1504:2008 products and systems for the protection and repair of concrete after removing the screws, one section at the time.	Removal of steel mesh to Structural engineers details. Repair of the existing fabric to BS EN 1504:2008 products and systems for the protection and repair of concrete after removing the screws, one section at the time.

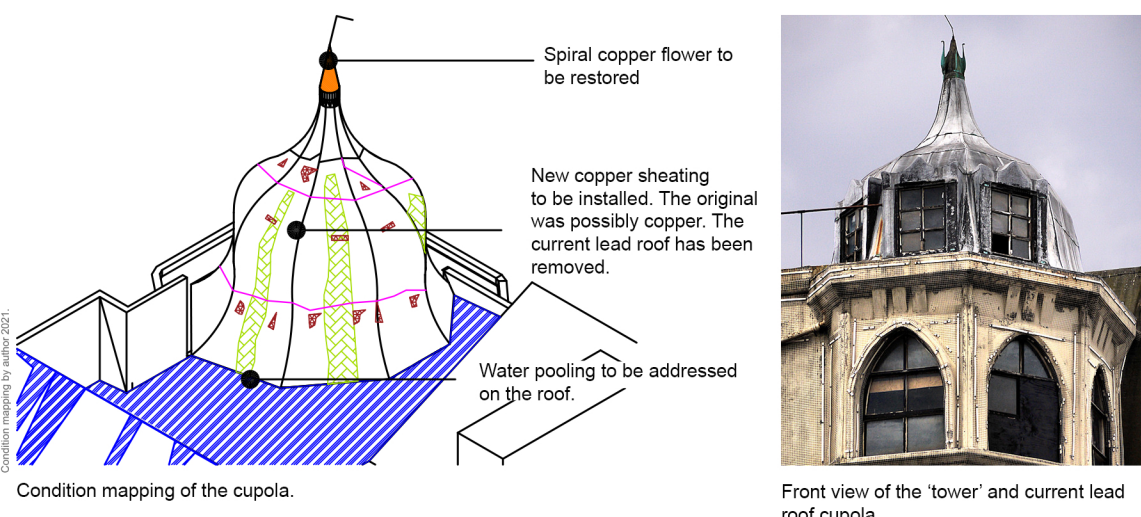
THE CUPOLA ROOF

Photo & Feature	Pathology	Cause of Decay	Recommended Further Investigation	Proposed Intervention
1) Existing bitumen type roof covering	Water stain Biological Deterioration Cracks in roof material	Possible bitumen roof coverings standing in water causing excessive decay + due to old age. Plants and vegetation growing on the roof due to wet conditions.	A full detailed visual inspection and measured survey of the roof is needed to be able to address any issues accurately.	Full replacement of roof to keep the building water tight. Removal of plants including removal of its roots.

2) Lead sheathing to cupola roof & copper flower spiral on the top	Water stain Biological Deterioration Erosion: Metal delamination Cracks in roof material and concrete	Lack of maintenance and aged materials. Slown leaching has increased any deterioration of the roof internally as well as externally. The original roof was covered in copper. Bird droppings can possibly have caused any corrosion on the metal. Plants and vegetation growing on the roof due to wet conditions.	A full detailed visual inspection and measured survey of the roof is needed to be able to address any issues accurately. Further inspection of the copper spiral.	Install new copper sheathing to the turret. The copper spiral should be cleaned, repaired & restored. Any corrosion should be removed. The copper spiral can be corrosion protected with benzotriazole (BTA) followed by protective wax coatings. CCRH regulations has to be followed using these (BTA) products.

3) Drainage, rainwater pipes etc.	Erosion: Metal delamination Other: Drainage issues	Lack of maintenance and aged materials. Pollution, bird droppings and acid rain increases erosion. Any drainage blockages can be caused by plant materials or infestations.	A full detailed visual inspection and measured survey of the roof is recommended and particularly a drainage inspection with cob cameras.	Replacement of eroded rainwater pipes and blocked drains. Larger pipes may be needed which may have a cosmetic / visual implication.

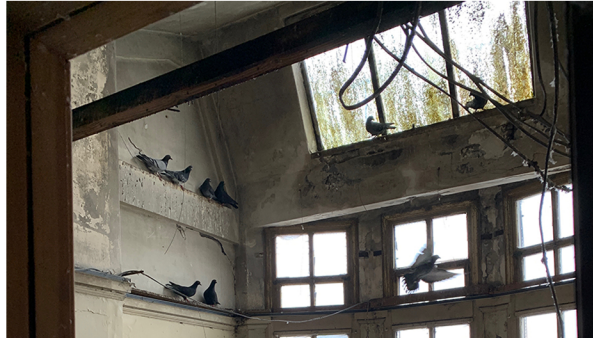
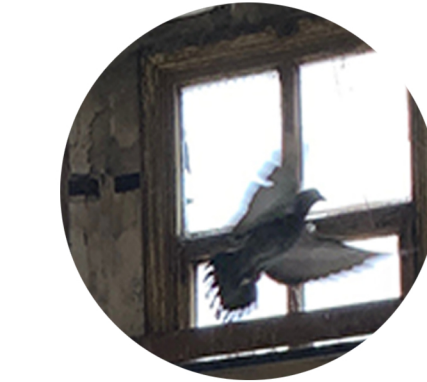
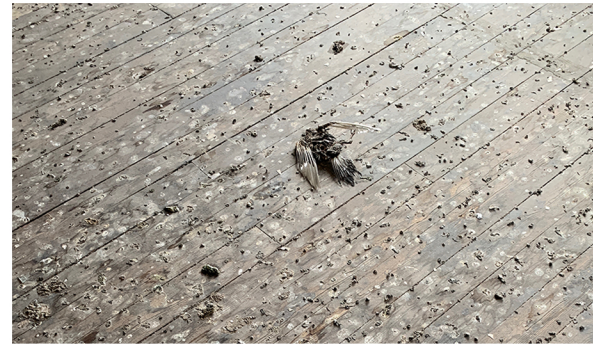
PIGEON & RAT INFESTATION

Pulmonary infections can be caused by dust from bird droppings, feathers and nesting materials when inhaled. It is important to first damp any droppings and to be removed by wooden spatulas and sealed in plastic bags. Larger quantities has to be handled by registered waste carriers. (English Heritage, Practical Building conservation, Odgers, 2012)

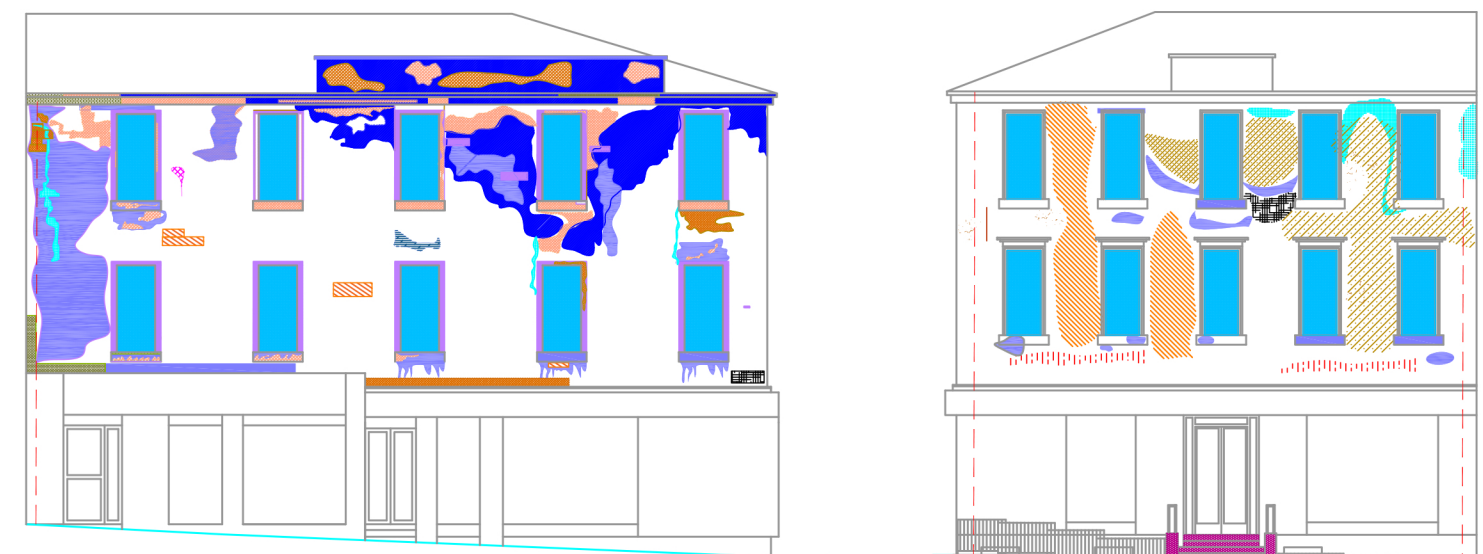
GEORGIAN CORNER BUILDING CONDITION MAPPING - HOPE STREET AND WEST REGENT STREET ELEVATION @ 1:200 @ A1
Original condition mapping drawing of georgian corner building, Scotland 2021, elaborated by author, 2021

Pathology	Cause of decay	Recommended further investigation	Proposed intervention
Water stain	Decayed and corroded watergoods due to old age, acid rain deteriorating the pipes and lack of maintenance. Water stains on walls and pooling of water on the roof are possibly due to decayed watergoods, blockages and poor detailing.	A full detailed visual inspection of the rainwater goods. CCTV cameras through drain pipes may be necessary to investigate any blockages/ damage.	Renewal of the rainwater goods perhaps also upgrading sizes due to additional rainfall and climate change.
Crust	Black crust generally consist of particles from the decomposition (degradation) trapped into a gypsum (CaSO4.2H2O) composite. Chromatic modification of the material, generally resulting from natural or artificial ageing and not involving in most cases visible surface deterioration. (Odgers, 2012)	Mineralogy and the sandstones petrology should be investigated. A sample clearing trial area has to be done before full application.	The use of clay pozzolite which allows for larger areas to be cleaned in a controlled manner.

Patina	Chromatic modification of the material, generally resulting from natural or artificial ageing and not involving in most cases visible surface deterioration. (Odgers, 2012)	Mineralogy and the sandstones petrology should be investigated. A sample clearing trial area has to be done before full application.	The use of clay pozzolite which allows for larger areas to be cleaned in a controlled manner.
Efflorescence	White soluble salt crystals on the surface. Caused by evaporation of saline water present in the porous stone structure. For example due to air pollution. (Odgers, 2012)	Chemical test to be made to find out salt composition. It can be sodium chloride/magnesium sulphates or can be made of less soluble salts like calcium sulphate or anhydrous silica.	Dry removal of the salts, brackish crusts of salts can be removed by scaled and vacuumed.
Blistering	Concentration of salts can cause blistering in sand stone. Salt crystallisation behind a water resistant coating of paint can cause larger areas of detachment of the sandstone.	Mineralogy and the sandstones petrology should be investigated. A sample clearing trial area has to be done before full application.	Careful removal of the paint. Labour intensive tools such as metal spatulas & scrapers. Dry air abrasion could also be used or dry poultice.

Exfoliation	A form of delamination where stone breaks off to layers which can be due to failure of the surface part of the stone. Thermal stress of the surface and underlying stone.	Mineralogy and the sandstones petrology should be investigated. A sample clearing trial area has to be done before full application.	Depending of depth of the delamination the stone may have to be replaced.
Paint on sand stone wall	Non permeable paint can cause damp issues and failure of the stone.	Investigate what type of paint is currently on the stone surface. The control of Lead at Work Regulations 1998 covers commercial situations.	Careful removal of the paint. Labour intensive tools such as metal spatulas & scrapers. Dry air abrasion could also be used or dry poultice.
Loss of pointing	Loss of pointing will cause water ingress and damp walls, which will decay the stone and mortar.	Ensure the lime mortar is compatible with the existing sandstone. Sample mortars should be tested on the wall.	Repoint with lime mortar.

Surface crazing (fine random cracks) to concrete steps, this is not an excessive flaking resulting in higher concentration of cement and fine aggregate in the surface.		A full detailed visual inspection and survey of the area. Structural engineers input for the new structure.	Due to a proposed new balcony area next to existing steps and new stone area for the basement. A new in situ cast smooth concrete steps area is proposed.
