THE LION CHAMBERS

PROPOSED CREATIVE CO-WORKING & LEARNING SPACE IN GLASGOW

PROPOSAL & CONSERVATION SUMMARY

CONSERVATION DESIGN PROJECT - ELINA MARIA YLIMAKI - 2020 / 2021

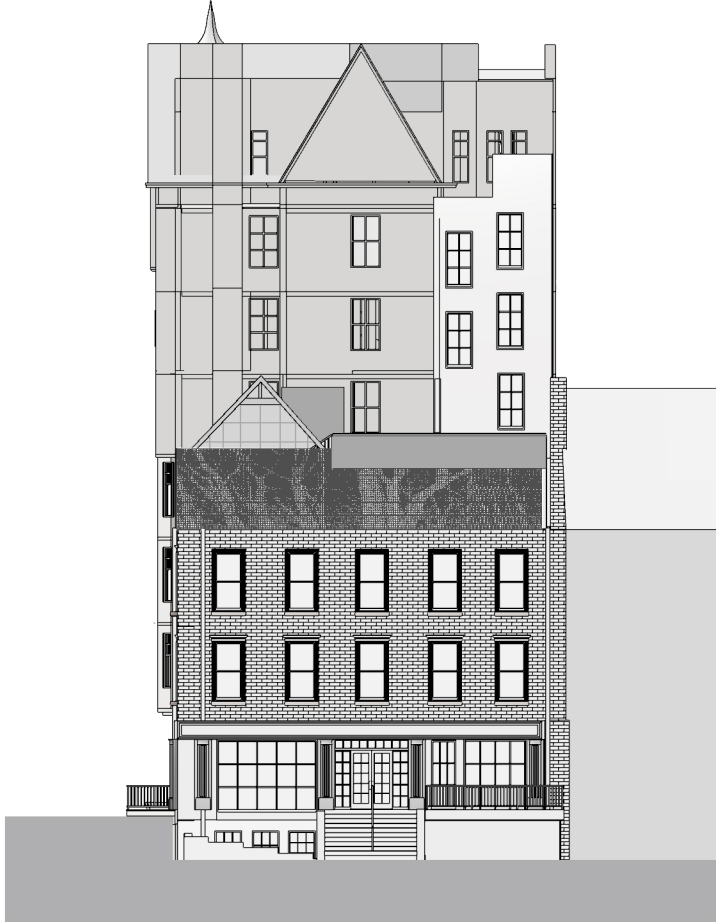
PROPOSED SOUTH WEST ELEVATION TO WEST REGENT STREET

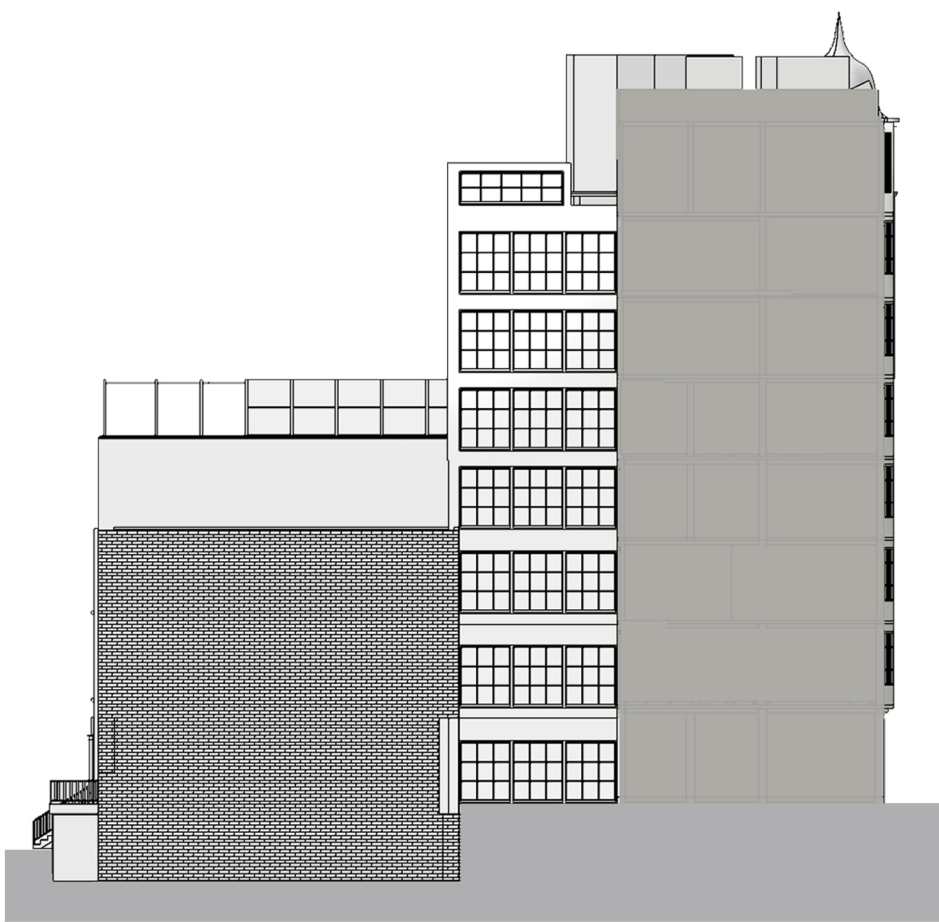
PROPOSED ELEVATION- REAR OR BUILDING

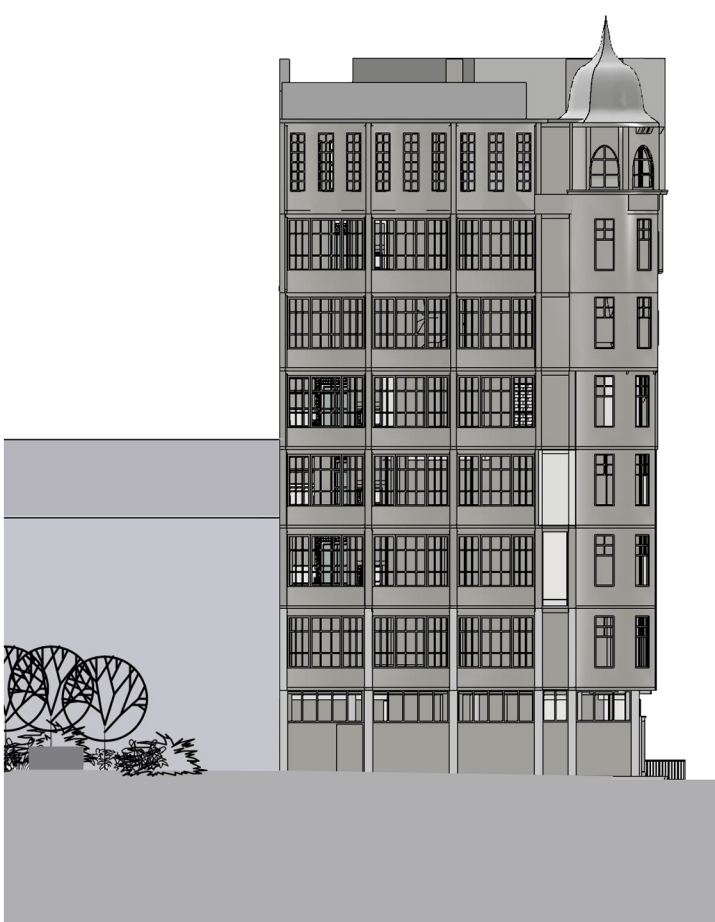
PROPOSED NORTH EAST ELEVATION TO BATH LANE

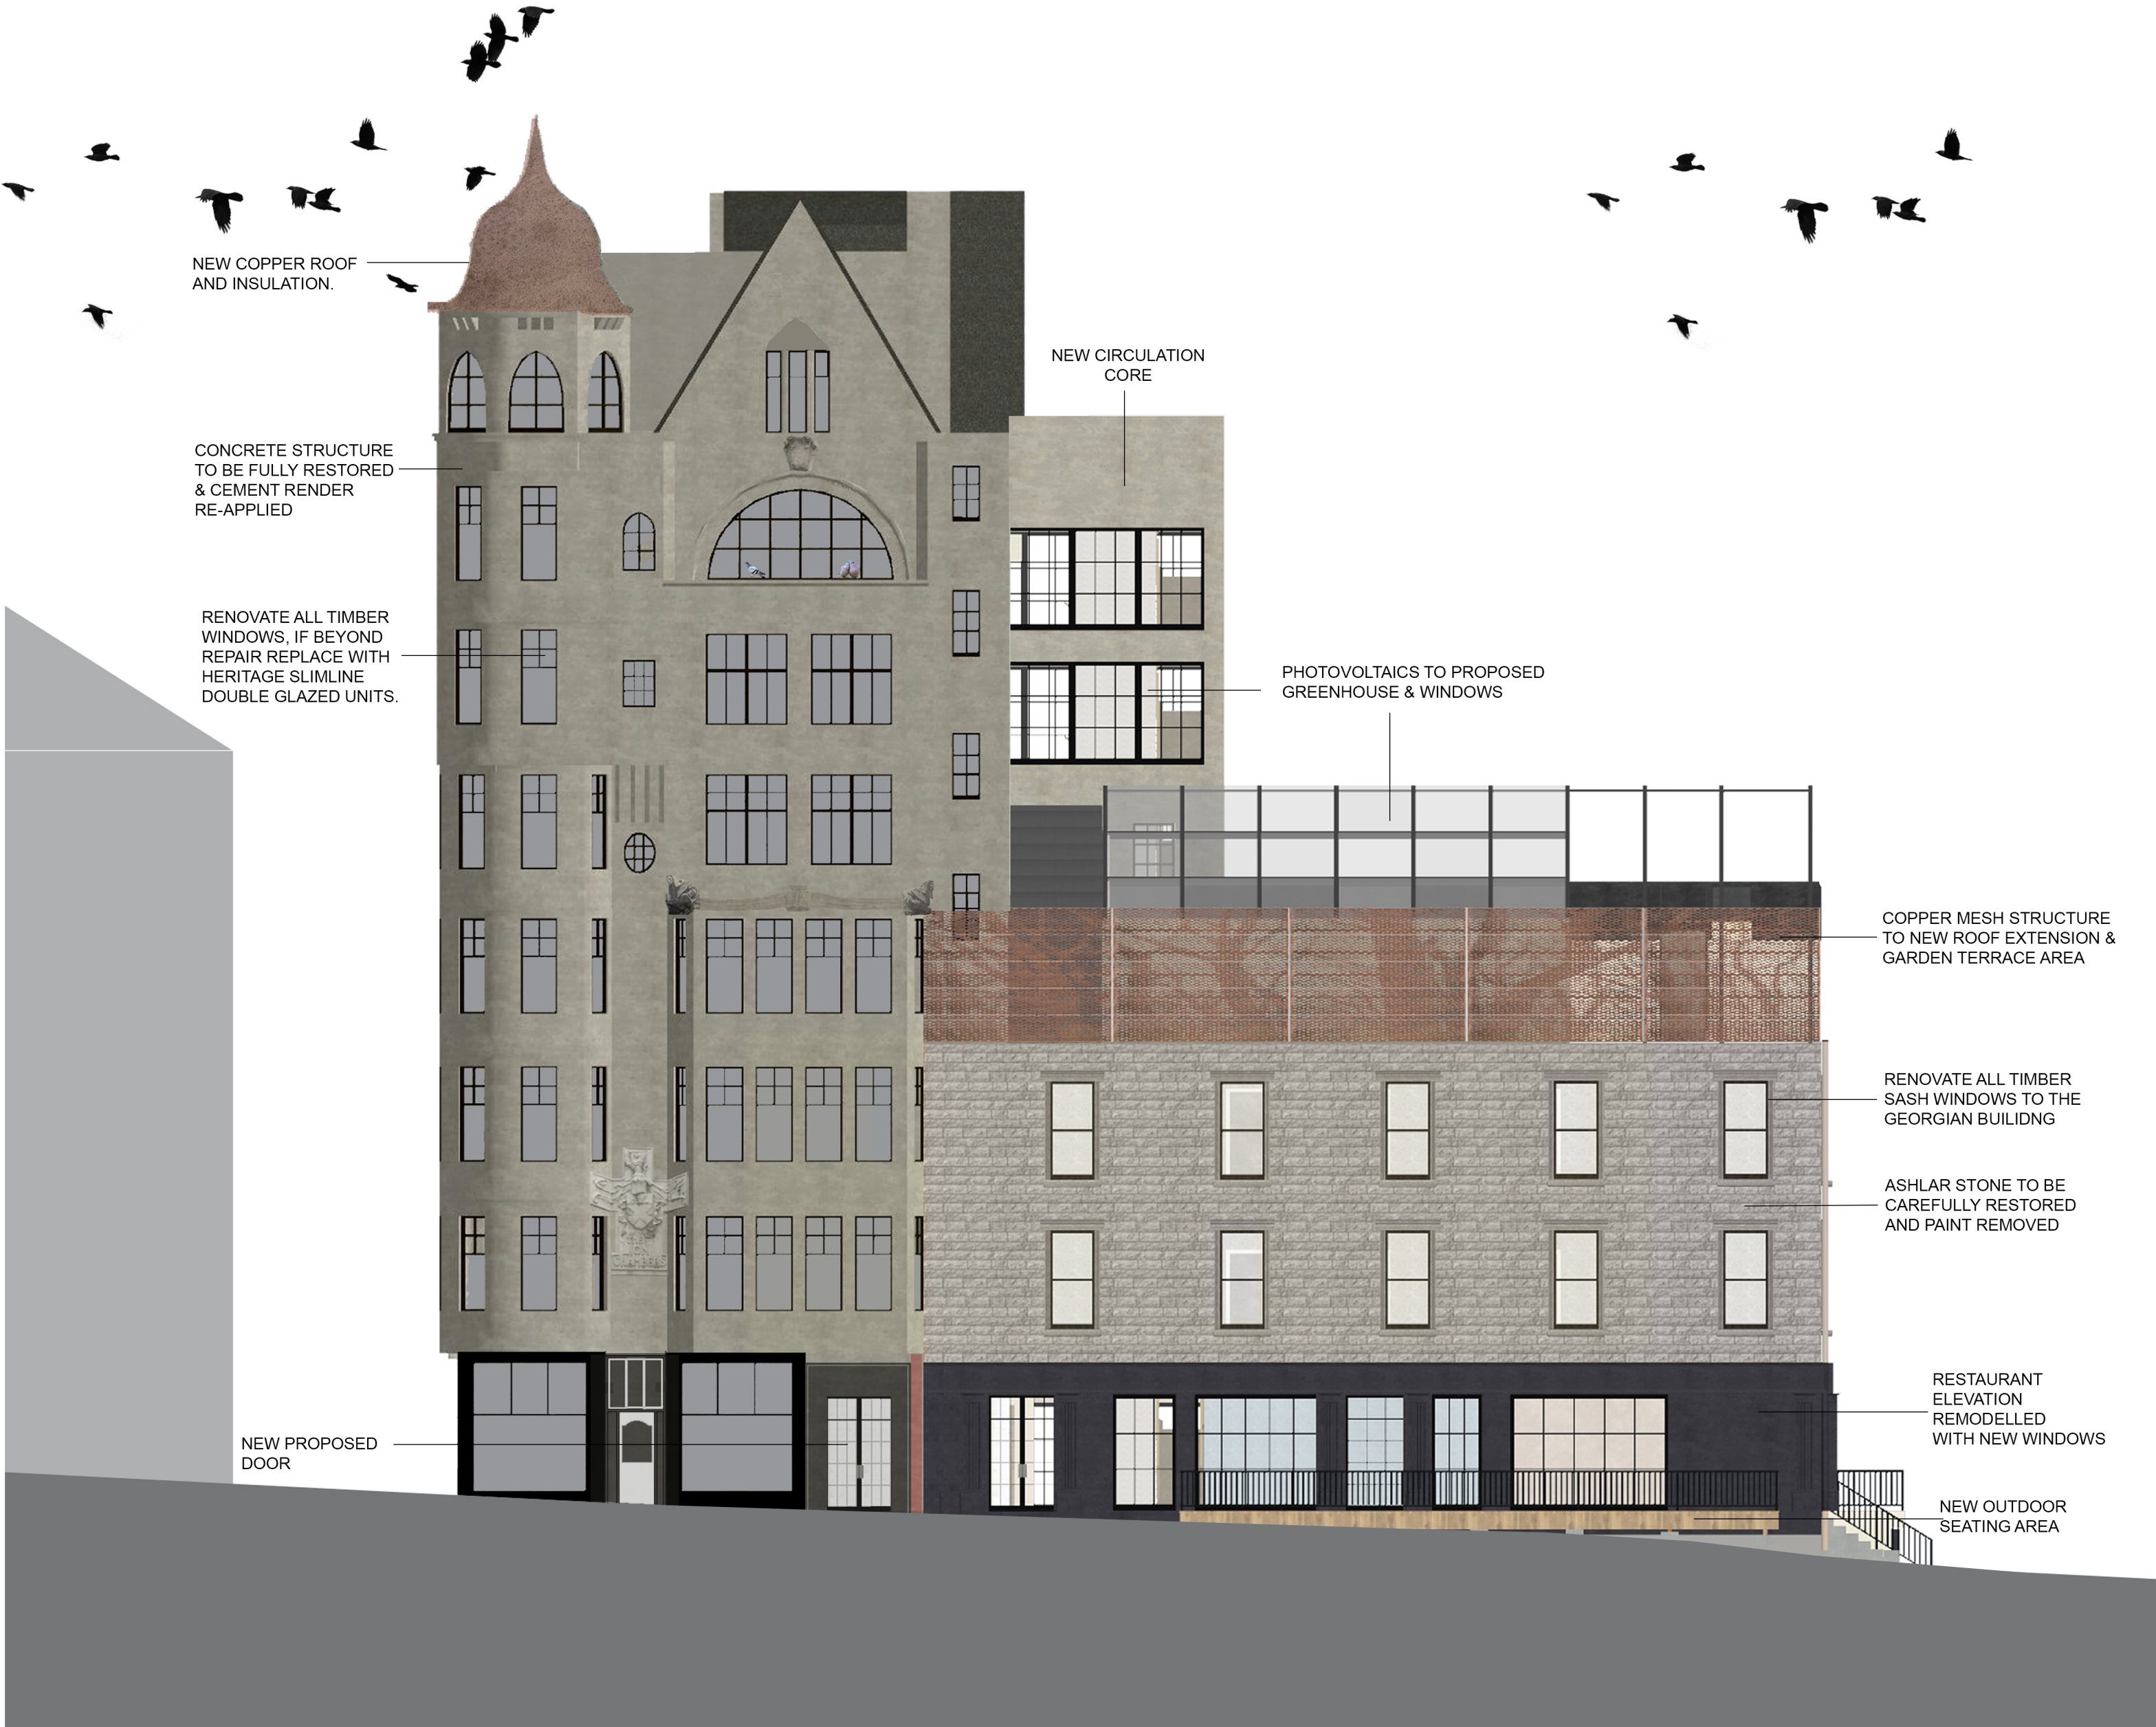
PROPOSED ELEVATION FROM HOPE STREET

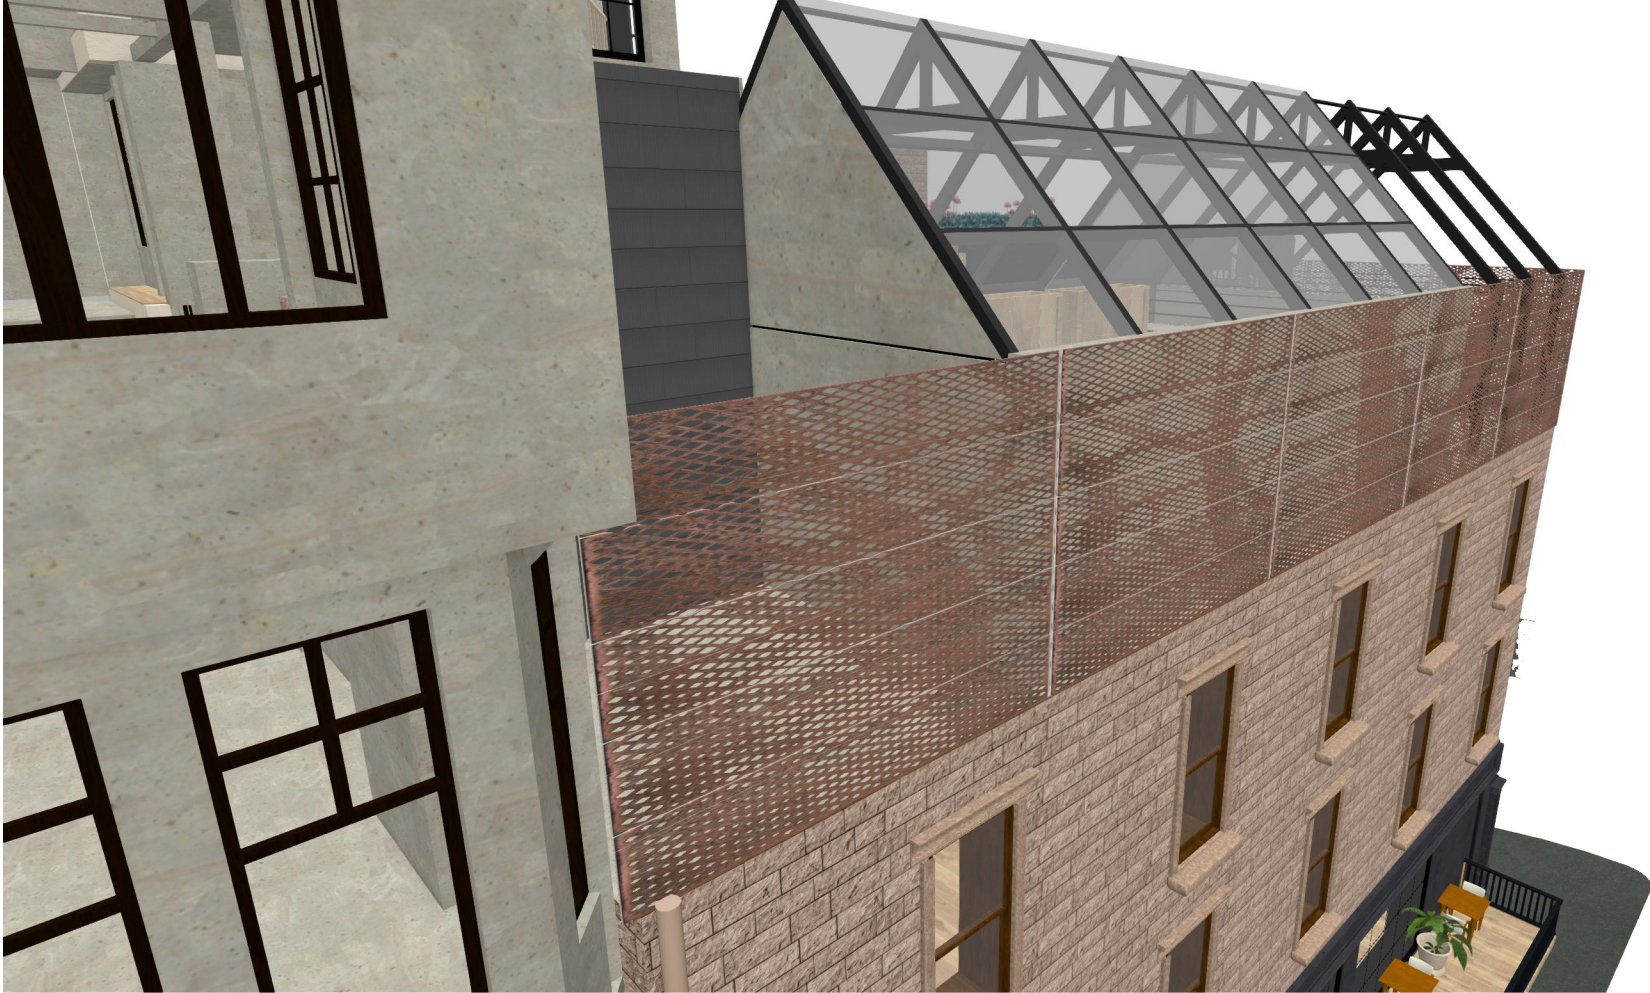
BIRDS EYE VIEW OF THE GREENHOUSE AT THE NEW GARDEN ROOF TERRACE

The roof will possibly need a complete replacement of broken roof cover- ings to keep the building watertight, removal of plants, including removal of its roots. Introduce a sedum roof system to parts of the roof to increase bio- diversity in the city and also introduce new roof insulation on top of the con- crete roof to help reduce its carbon footprint. The Turret Install new copper sheeting to the turret.
